PK

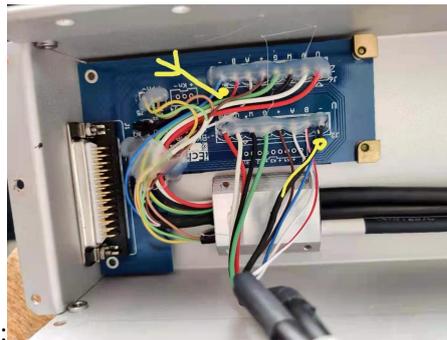
13. If all the drives misreport AL011:

Cut the shield line off the head:
