## How to check and solve BK3 X1 axis abnormal noise

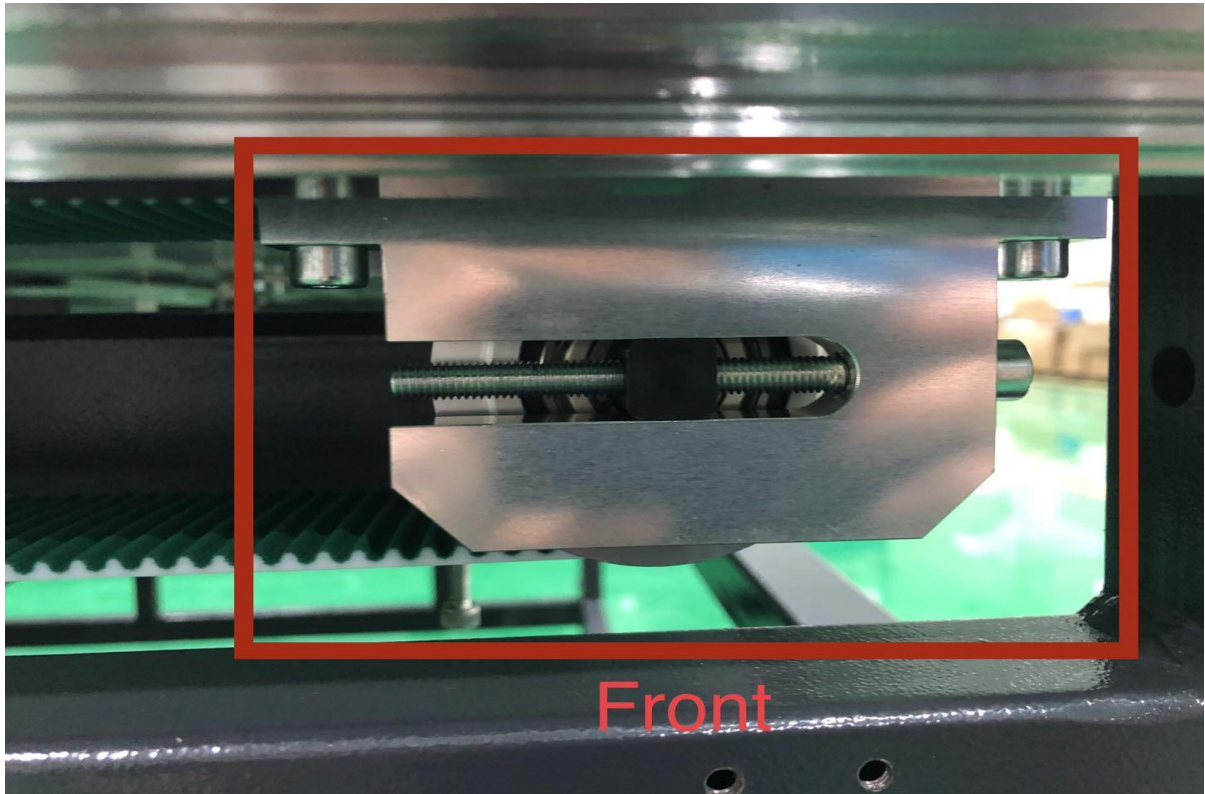
Figure1

1. First, you need to remove the side cover and pause button boxes to find the bearings in front of and behind.

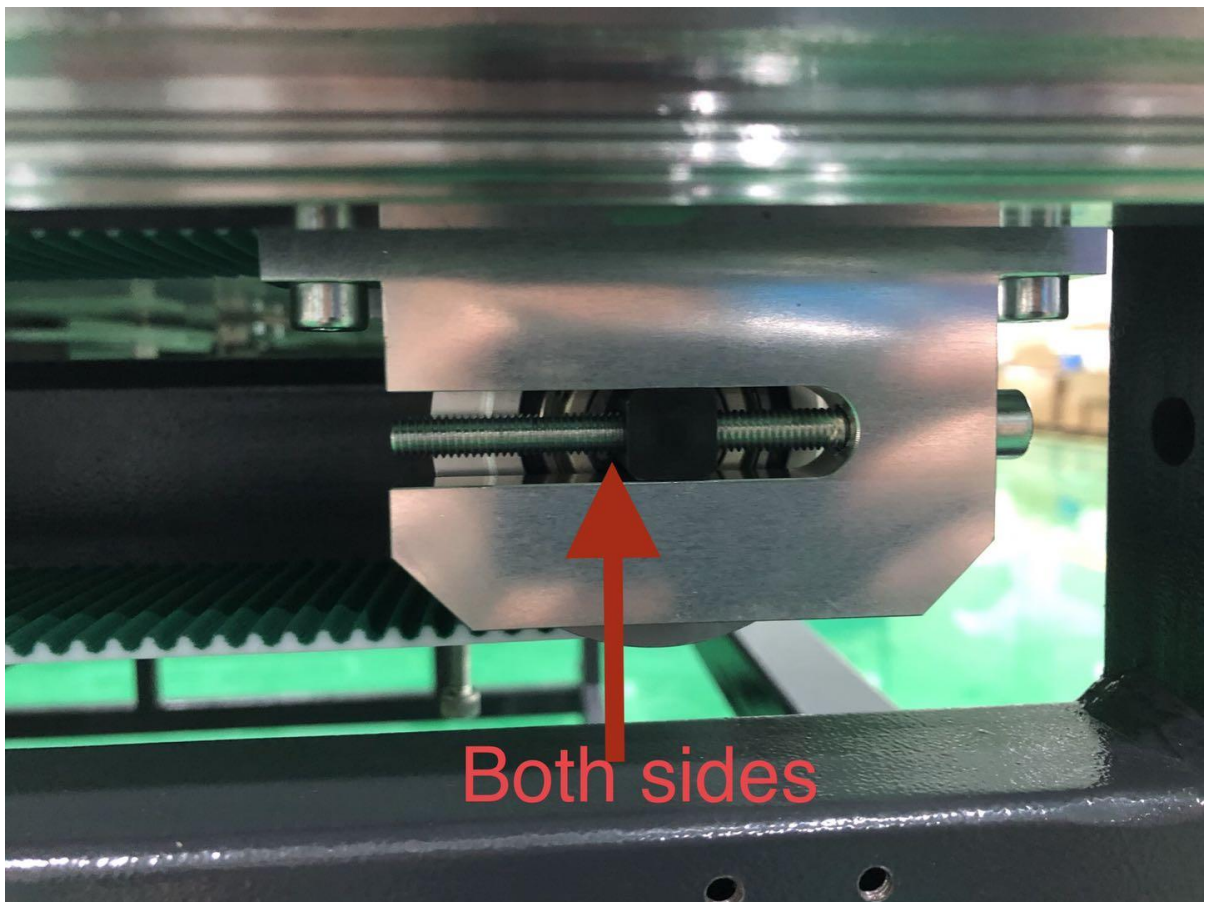
Figure3

2. When you start to remove the bearing, remember to mark on the front screws to ensure that you install the new bearing in the same position as the original, so as to ensure the same tension of the belt (Figure 3) . You need to loosen these two screws for the front bearing and loosen the seven screws on the back. ( Figure 4 and Fingure 5 ) Can refer to the Figure below for disassembly and assembly.

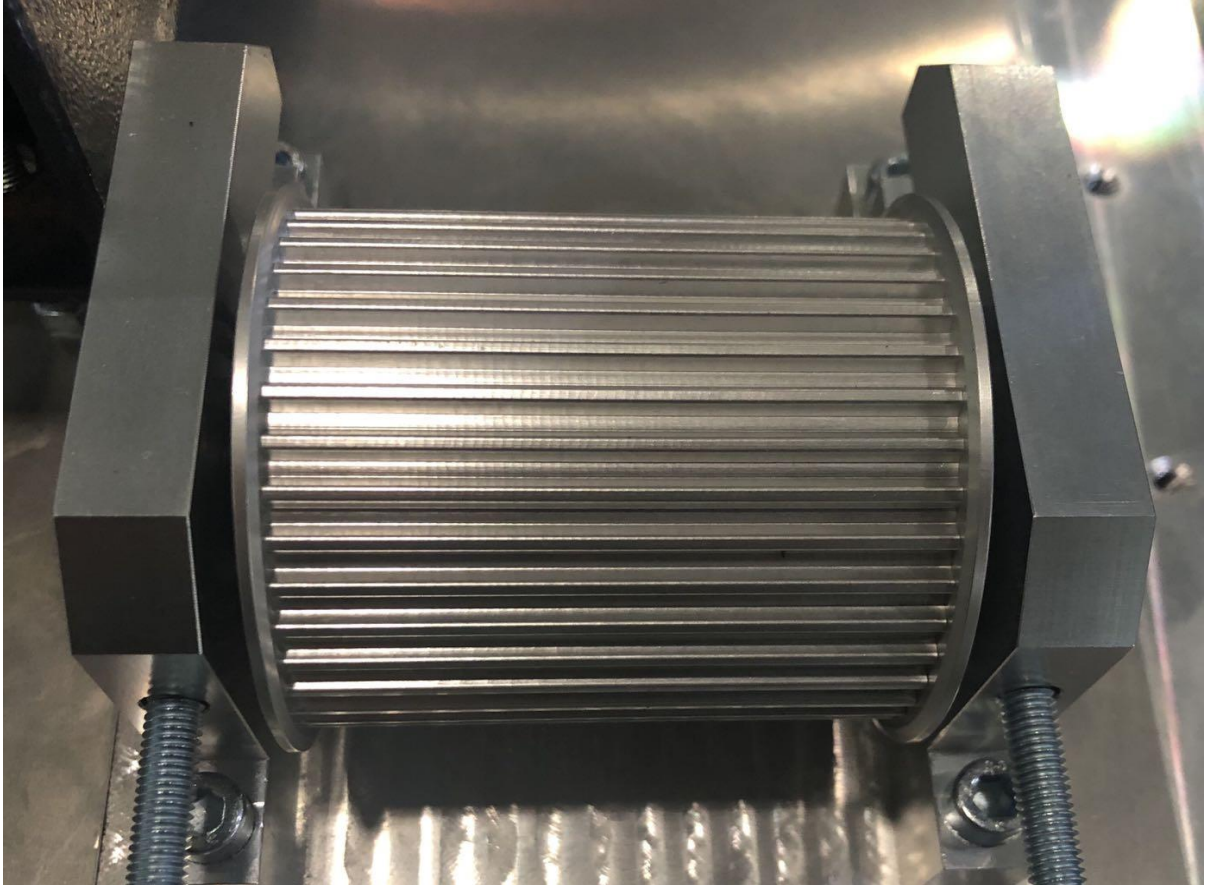
序号	物料名称	物料编号/物料规格	数量
Figure8	BK3 带轮 38	1.10.01.0000362	1
Figure9	带止动槽深沟球轴 承	1.20.05.0000278 6202-ZNR	2
Figure10	BK3 从动轮轴	1.10.01.0000350	1
Figure11	轴用弹性挡圈	1.10.01.0001159 GB/T894.1/15	2
Figure12	NSK 深沟球轴承	1.20.05.0000054/61906-zz/6906zz	1
